VEHICLE REPORT

# Lexus NX Series

2020

VIN | JTJYERBZ4M0101001

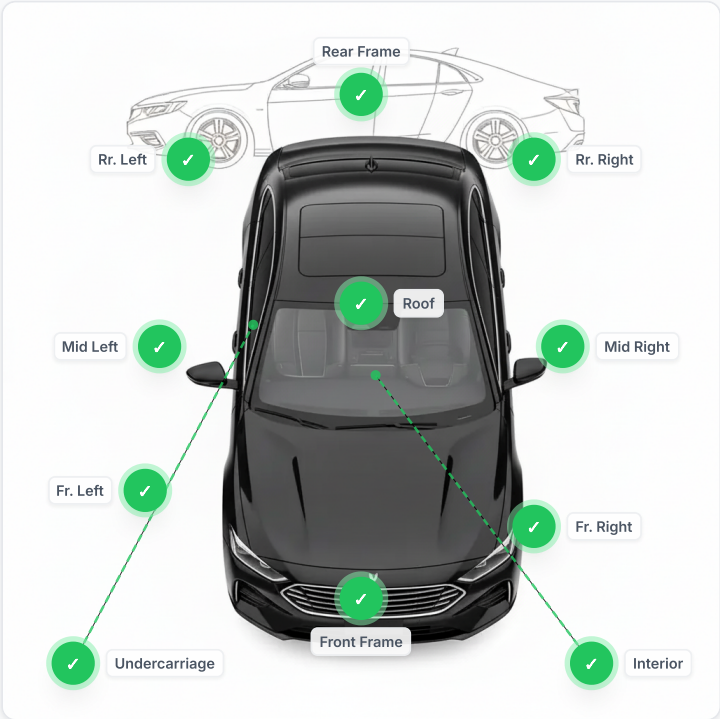
## Body Appearance Checklist

### Excellent Condition

Vehicle body and structure are in excellent condition with no damage detected

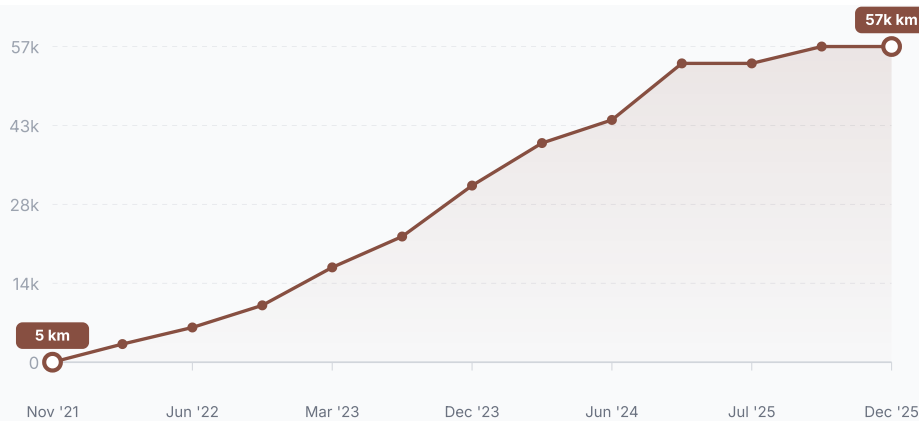
ODOMETER TREND

56,876 km

**Odometer Verified**

Mileage Verified - No Anomalies Detected
